Manhole Inspection Summary

Manhole # S67Y__016MH

Location Address: **6300 Beckly St.**

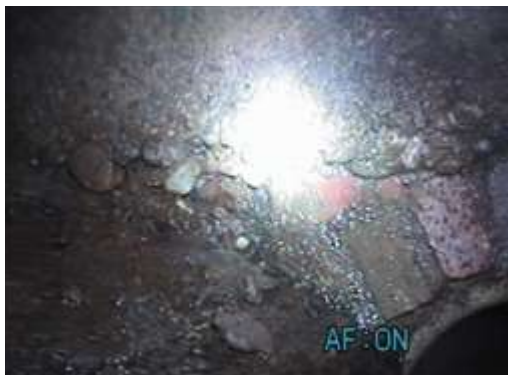
Defect 3

Condition: ☐ Sound ☐ Cracked ☐ Root Intrusion ☐ Deteriorated ☐ Leaks ☒ **Debris**

Debris on bench

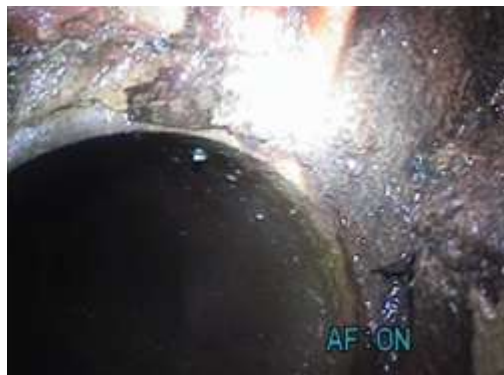
Defect 2

Pipe seal crack O12

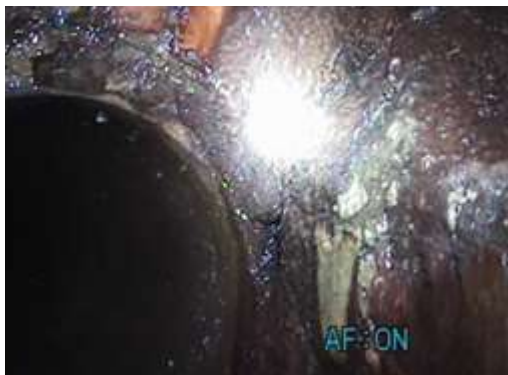
Defect 5

Infiltration at pipe seal O12

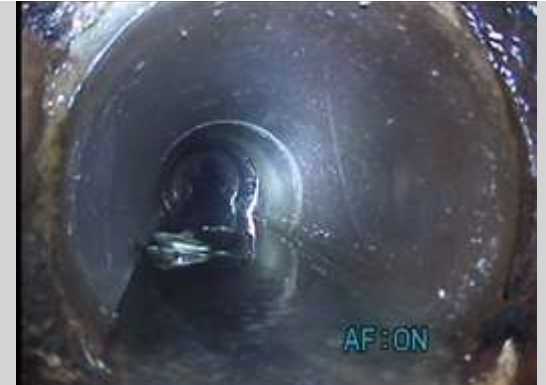
12 O'Clock Outflow

12 in. Circular Gravity Sewer
Pipe Out @ 12 O'Clock

Pipe Height: **13.2** (in.) Rod and Bar (Angled)
Pipe Material: **Clay** ☐ Pipe Lined
Invert Depth: **8.54** (ft.) Flow Characteristics: **Slow**
Deposits: ☐ None ☐ Mud ☐ Gravy ☒ Debris ☐ Grease
Silt Depth: **0.25** (in.) Deposits Extent: **Light**
Infiltration: **Dripper** Pipe Seal Cond: **Cracked**

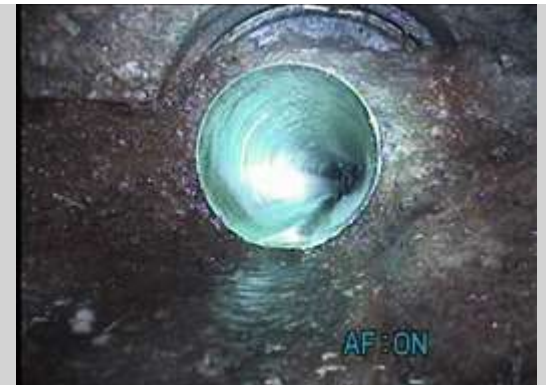
2 O'Clock Inflow

6 in. Circular Gravity Sewer
Pipe In @ 2 O'Clock

Pipe Height: **7.2** (in.) Rod and Bar (Angled)
Pipe Material: **PVC** ☐ Pipe Lined
Invert Depth: **7.90** (ft.) Flow Characteristics: **None**
Deposits: ☒ None ☐ Mud ☐ Gravy ☐ Debris ☐ Grease
Silt Depth: (in.) Deposits Extent:
Infiltration: **None** Pipe Seal Cond: **Sound**

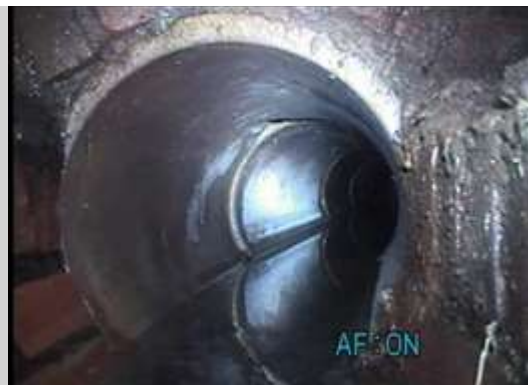
7 O'Clock Inflow

12 in. Circular Gravity Sewer
Pipe In @ 7 O'Clock

Deposits: ☐ None ☐ Mud ☒ **Sludge** ☐ Debris ☐ Grease

Silt Depth: **0.25** (in.) Deposits Extent: **Light**
